SCREENING SITE INSPECTION REPORT

WOODLAND LDFL INC

SOUTH ELGIN, ILLINOIS

OCTOBER 16, 1991

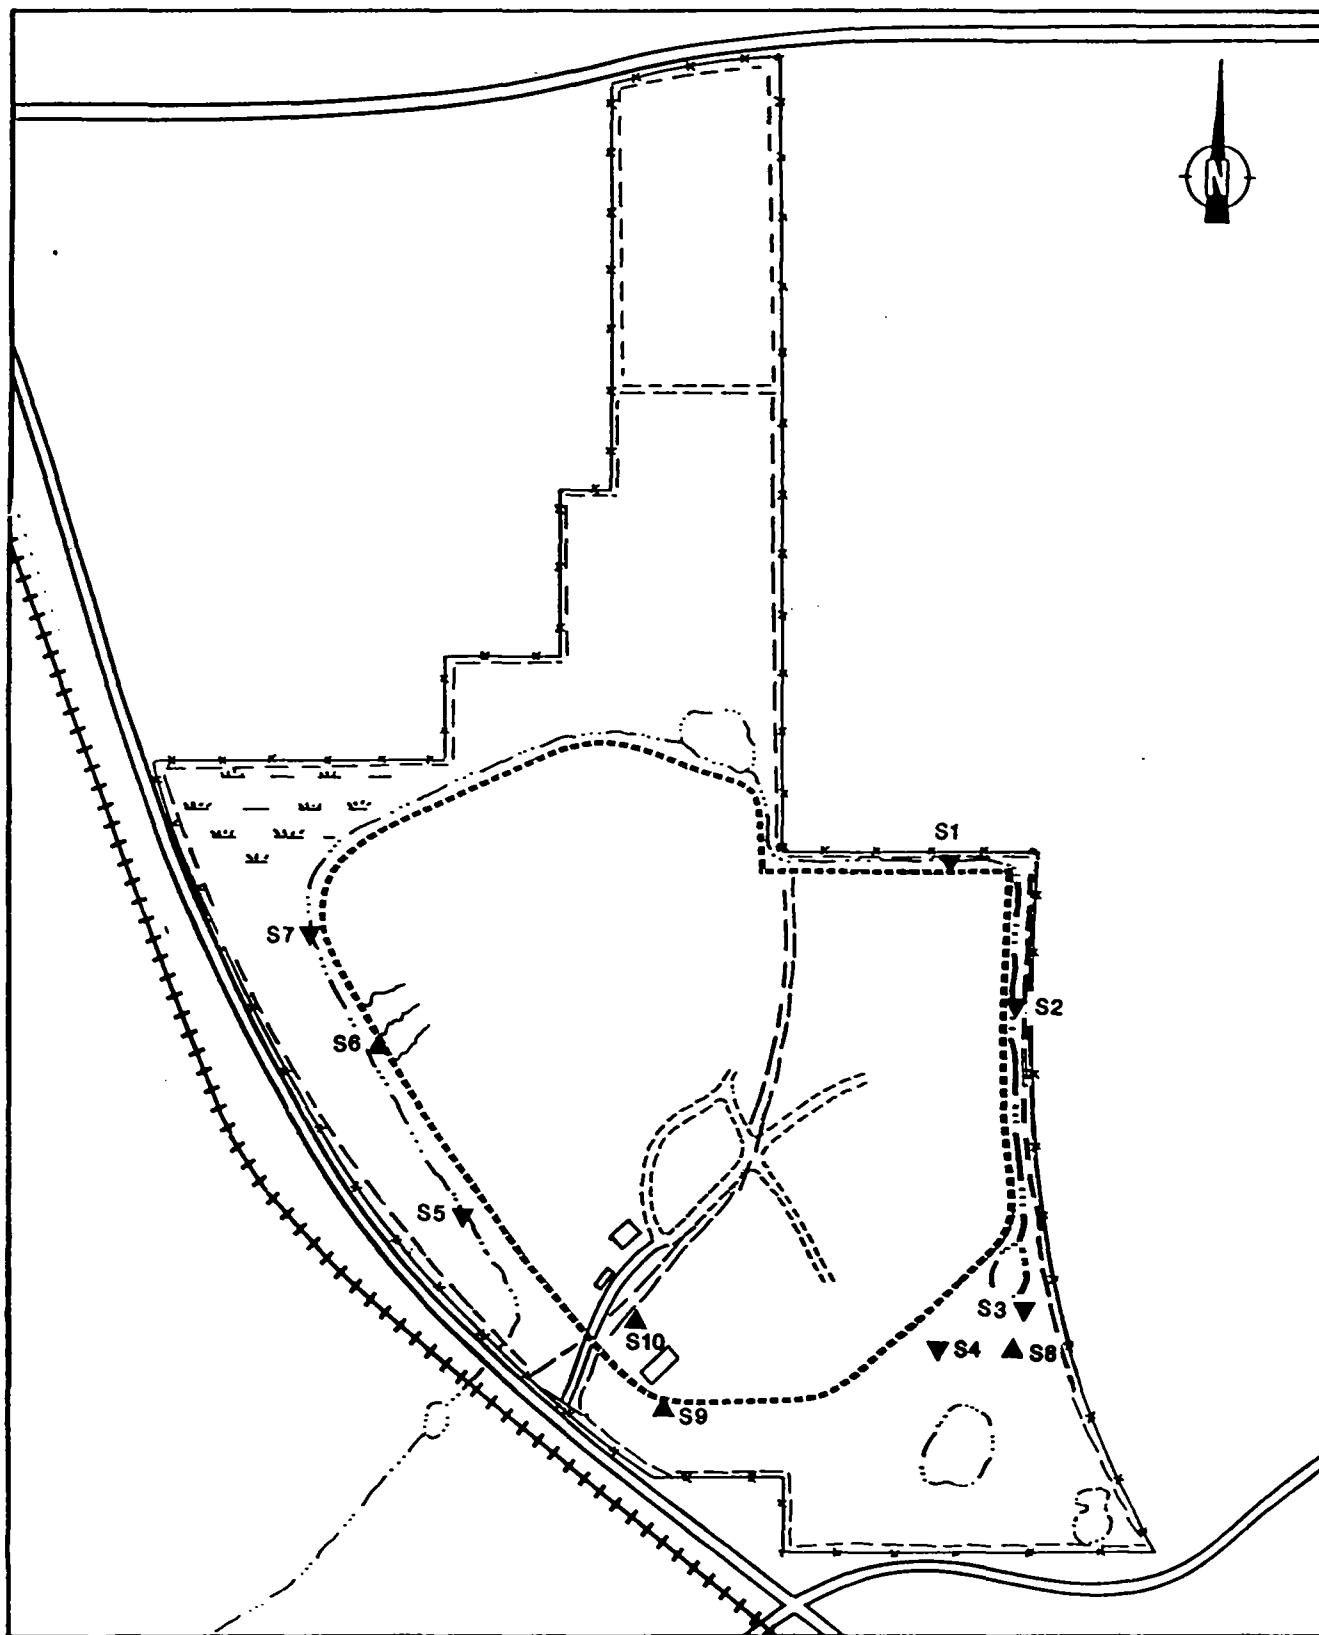
Soil/Sediment Sampling Procedures. Sediment sample S1 was collected from the drainage ditch that borders Phase II to the north (see Figure 3-2 for soil/sediment sampling locations). Sediment sample S2 was also collected from the drainage ditch, at the eastern border of Phase II, approximately 600 feet southeast of sample S1. Sediment sample S3 was also collected from the eastern border of Phase II, approximately 1,200 feet south of sample S2. Sediment sample S4 was

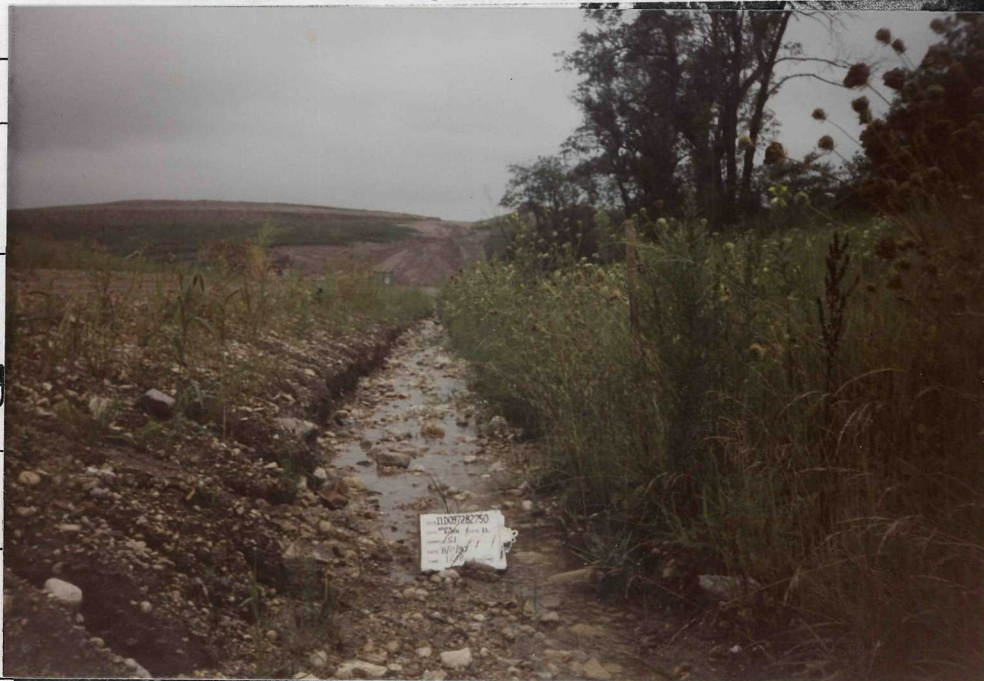
DESCRIPTION: Perspective view of Sediment Sample S1 collected
AT NORTHEAST EDGE OF SITE.

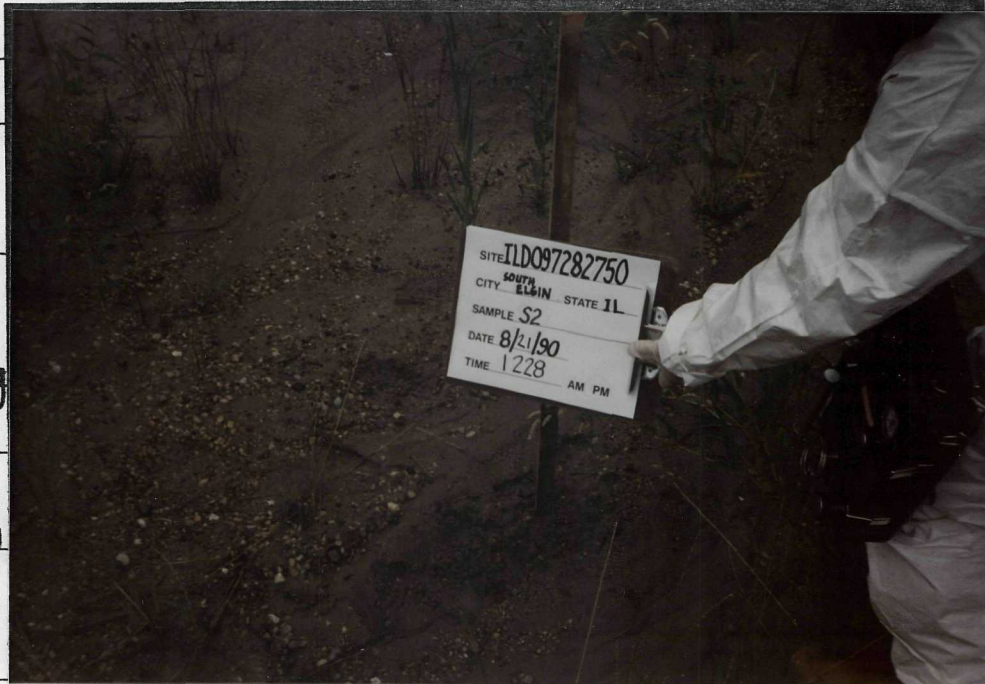
DESCRIPTION: CLOSEUP OF SEDIMENT SAMPLE S2 COLLECTED AT
NORTHEAST edge of SITE.DATE: 8/21/90TIME: 12:34DIRECTION OF
PHOTOGRAPH:
SSEWEATHER
CONDITIONS:
cloudy, drizzling
70°FPHOTOGRAPHED BY:
Daniel SullivanSAMPLE ID
(if applicable):
S2

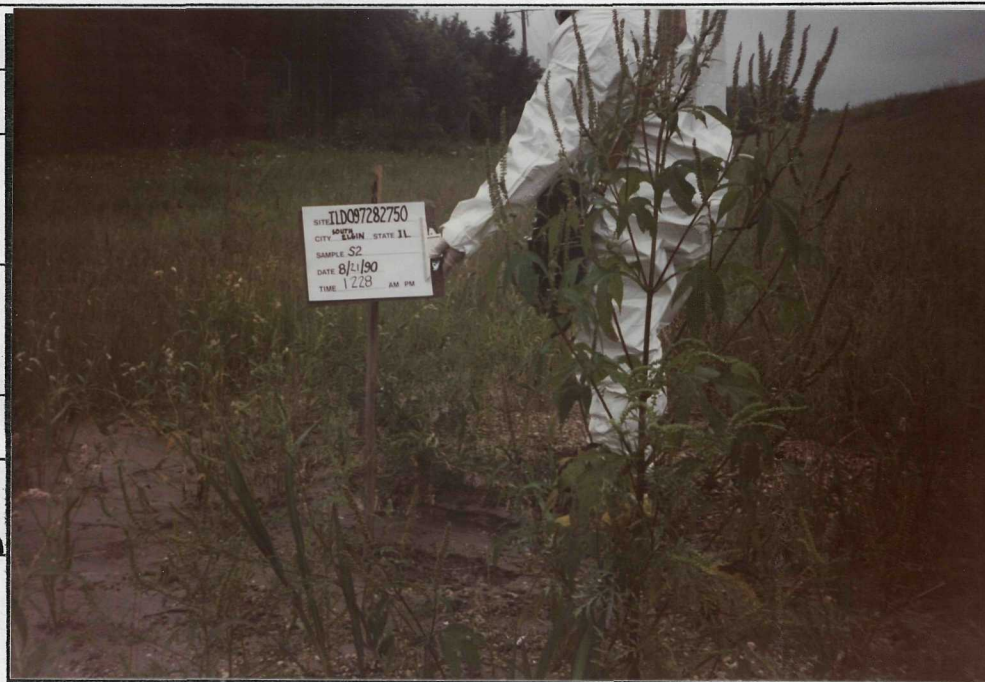
DESCRIPTION: PERSPECTIVE VIEW OF SEDIMENT SAMPLE S2 COLLECTED FROM THE
NORTHEAST edge of THE SITE.

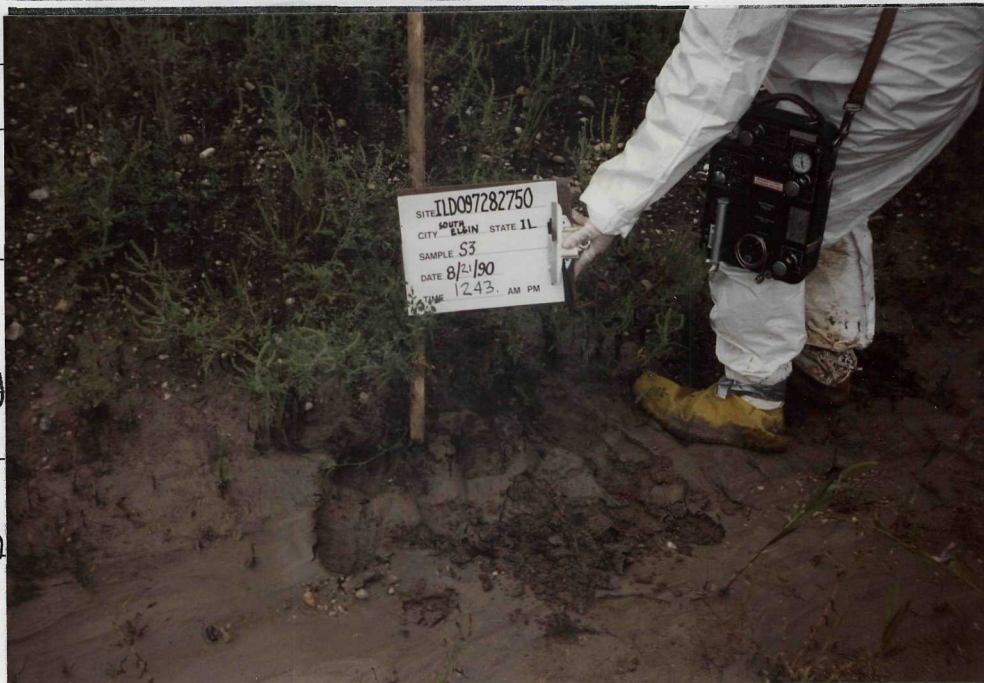
DESCRIPTION: CLOSEUP of Sediment sample S3 collected FROM the
EASTERN EDGE OF the SITE.DATE: 8/21/90TIME: 12:48DIRECTION OF
PHOTOGRAPH:
NNWWEATHER
CONDITIONS:
cloudy, drizzling
70°FPHOTOGRAPHED BY:
Daniel SullivanSAMPLE ID
(if applicable):
S3

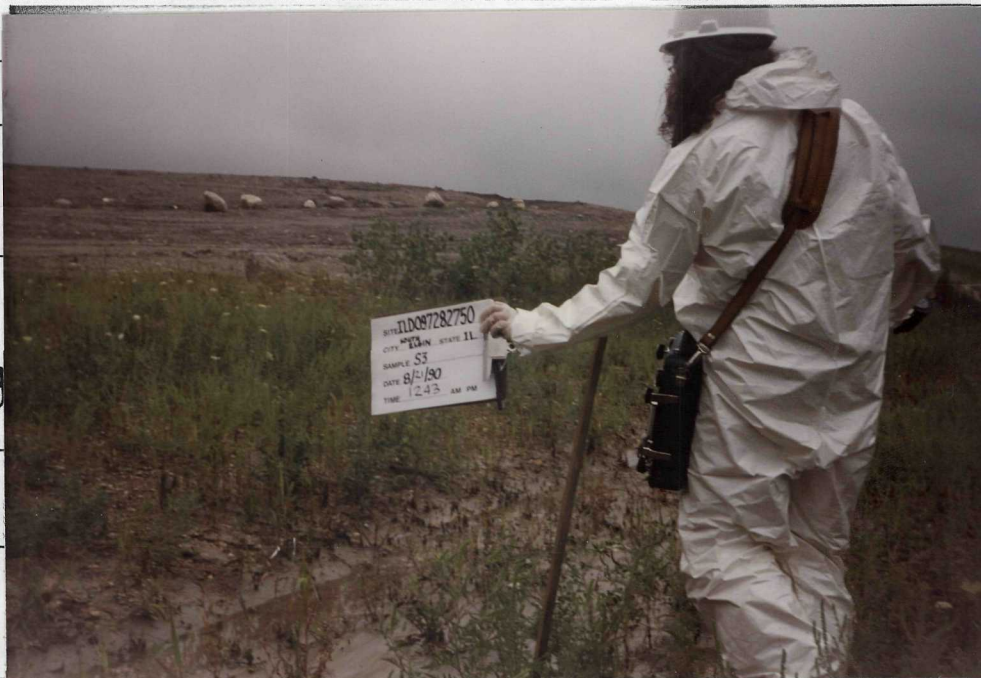
DESCRIPTION: Perspective view of Sediment sample S3
collected FROM the EASTERN edge of the site, which
is PROMINENTLY eroded.

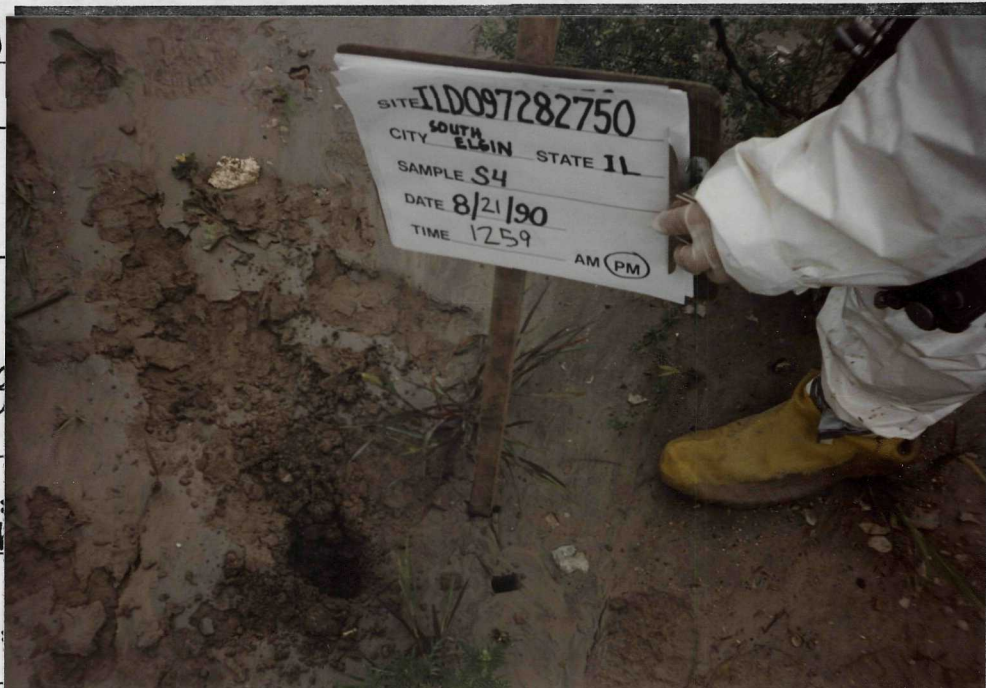
DESCRIPTION: Closeup of the location where Sediment sample S4 was collected.DATE: 8/21/90TIME: 13:03DIRECTION OF
PHOTOGRAPH:
NEWEATHER
CONDITIONS:
cloudy, drizzling
70°FPHOTOGRAPHED BY:
Daniel SullivanSAMPLE ID
(if applicable):
S4

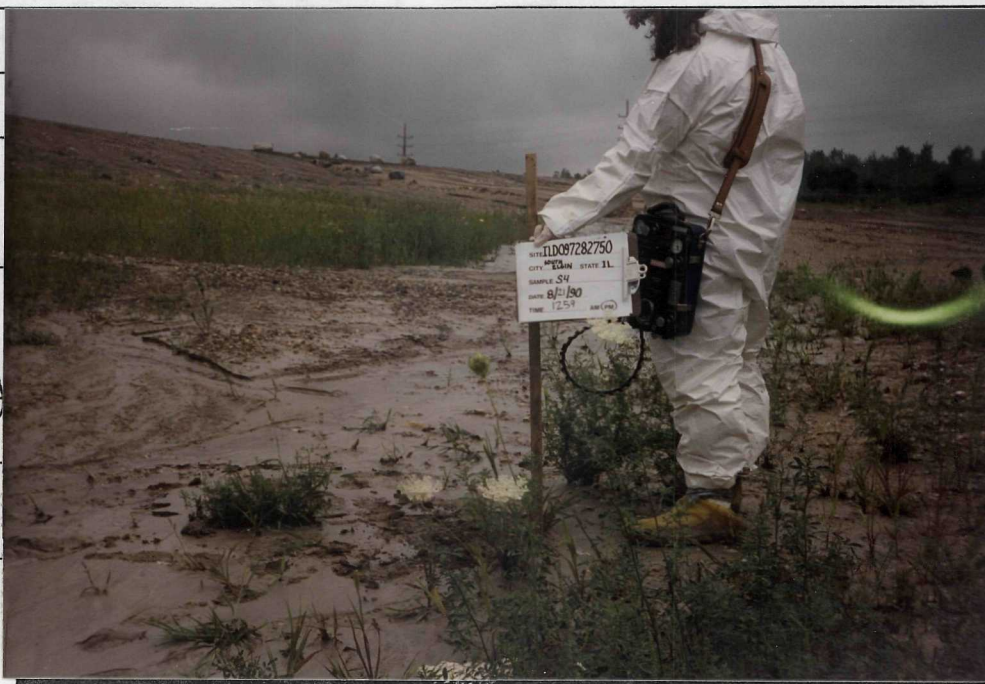
DESCRIPTION: Perspective view of Sediment sample S4 collected from the southeastern area of the site. The entire east side of the site suffered from erosion.

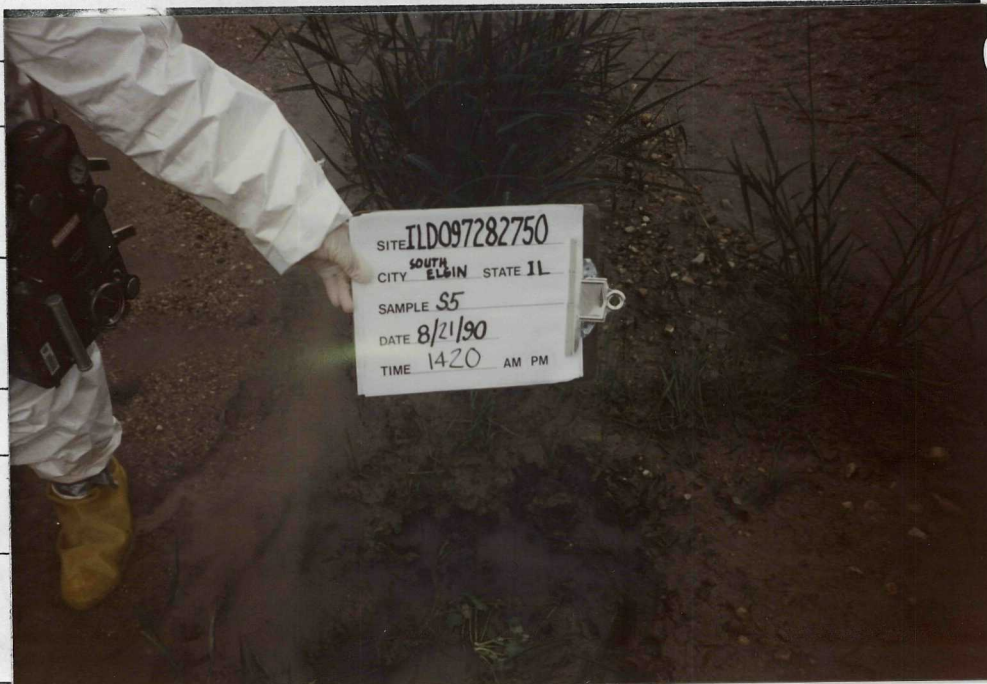
DESCRIPTION: Closeup view of location at which Sediment
Sample S5 was collected.DATE: 8/21/90TIME: 14:25DIRECTION OF
PHOTOGRAPH:S

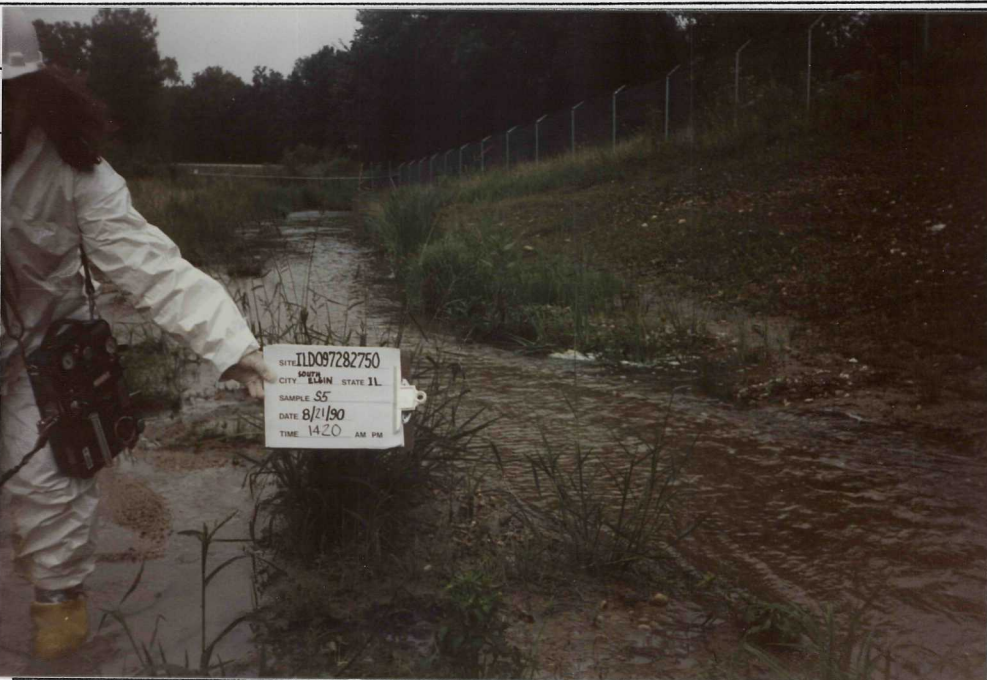
DESCRIPTION: Perspective view of sediment Sample S5 collected
from the western side of the site. The west side of the site has a
tributary to Brewster so it is an overland surface migration pathway.

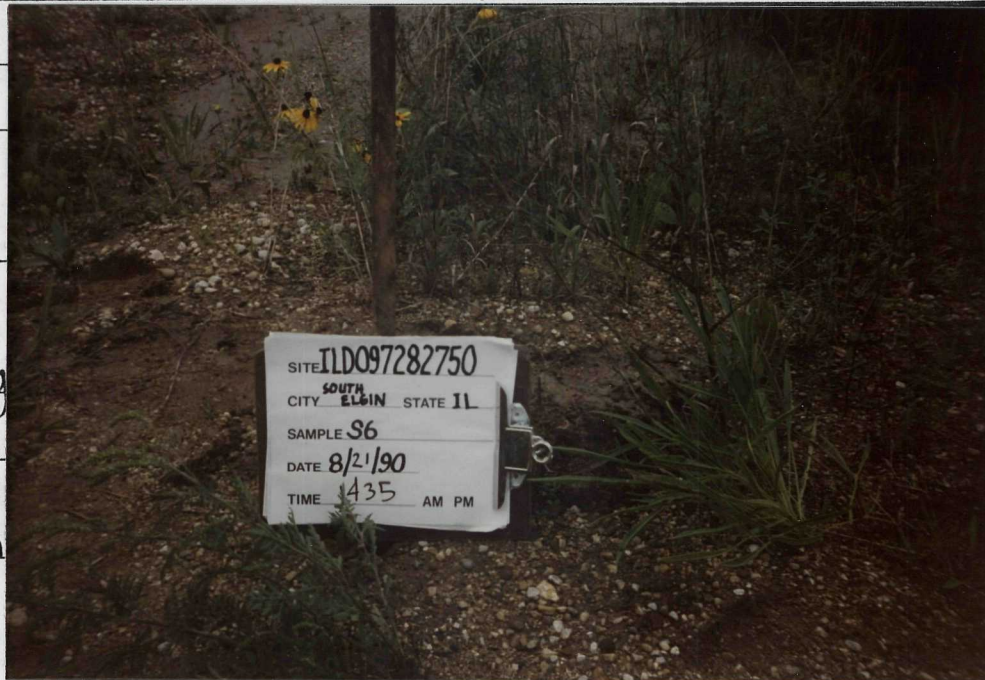
DESCRIPTION: Closeup view of location at which Sediment sample S6 was collected.DATE: 8/21/90TIME: 14:40DIRECTION OF
PHOTOGRAPH:N

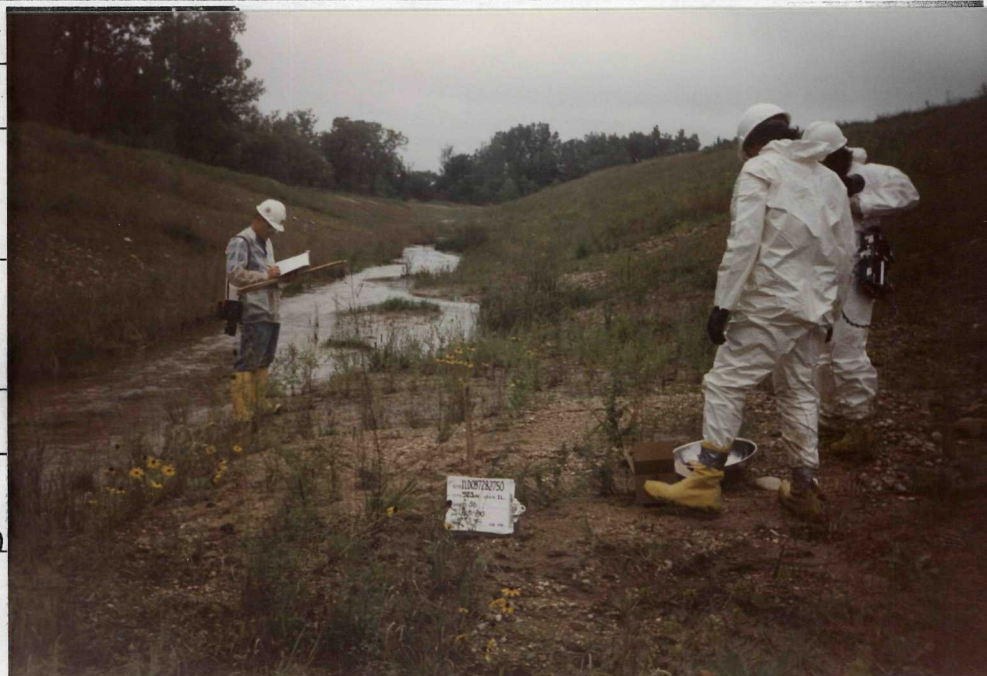
DESCRIPTION: Perspective view of Sediment sample S6 collected from the western side of the site.

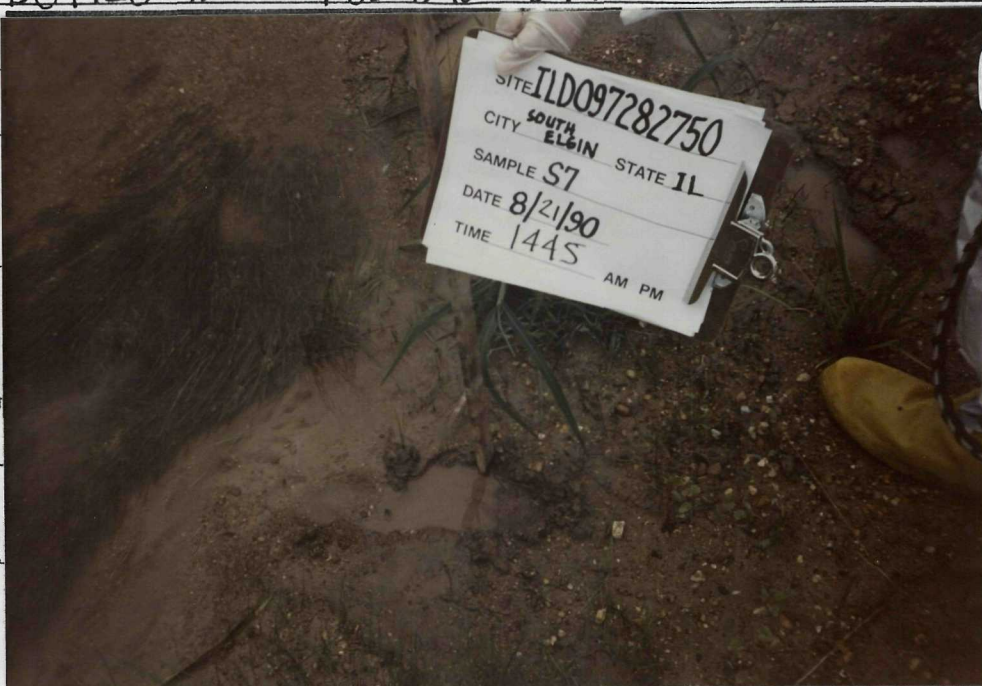
DESCRIPTION: Closeup of location at which sediment sample S7
was collected.DATE: 8/21/90TIME: 14:50DIRECTION OF
PHOTOGRAPH:
SWEATHER
CONDITIONS:Cloudy, drizzling
70°FPHOTOGRAPHED BY:
Daniel SullivanSAMPLE ID
(if applicable):
S7

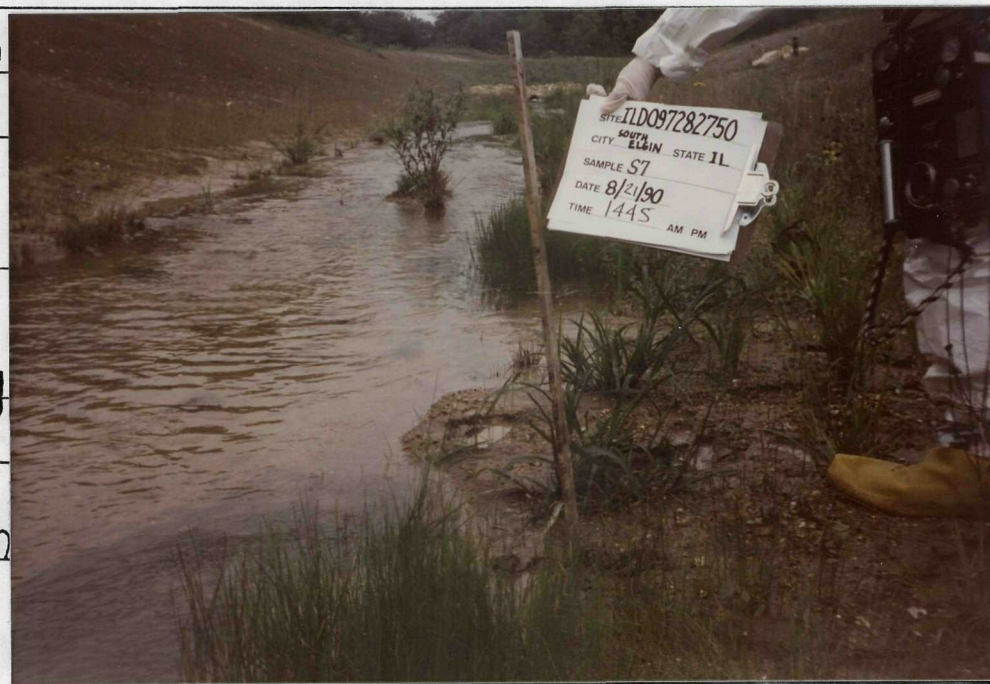
DESCRIPTION: Perspective view of sediment sample S7 collected
from the northwestern area of the site. (The tributary to Brewster
is shown.)

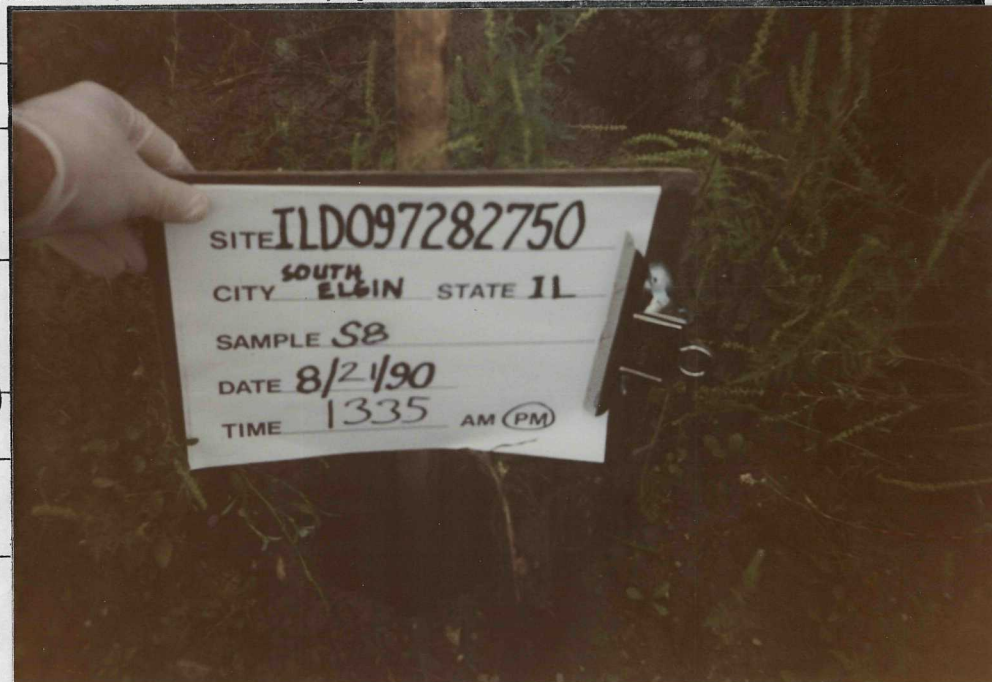
DESCRIPTION: Closeup of location at which sediment sample S8
was collected.DATE: 8/21/90TIME: 15:35DIRECTION OF
PHOTOGRAPH:
NWWEATHER
CONDITIONS:Cloudy, drizzling
70° F

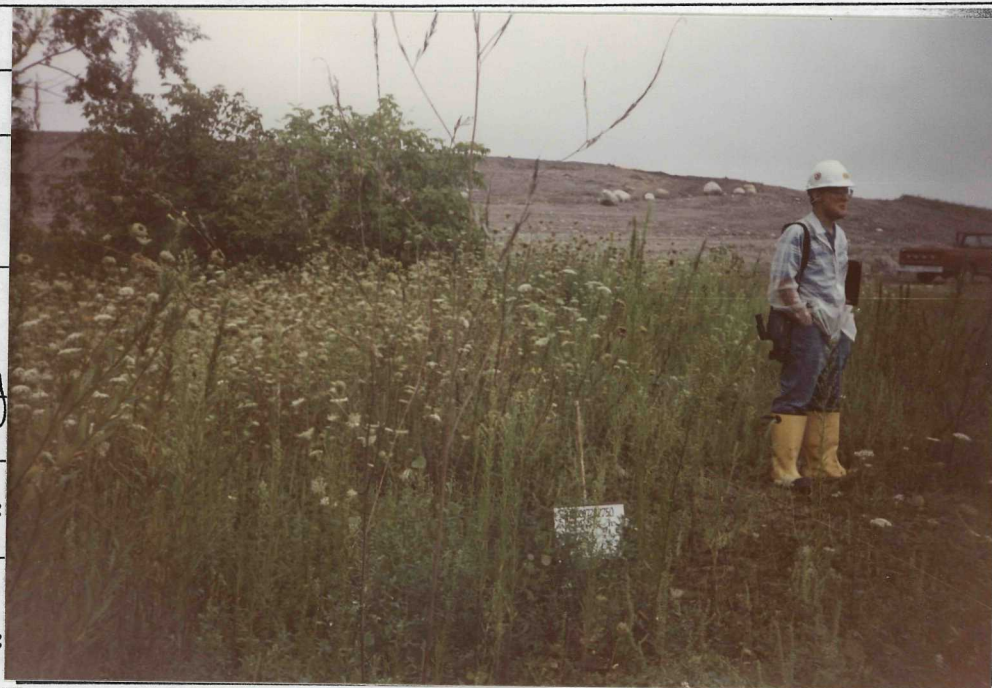
DESCRIPTION: Perspective view of sediment sample S8 collected
from the southeastern area of the site. The east side of the
site is prominently eroded.

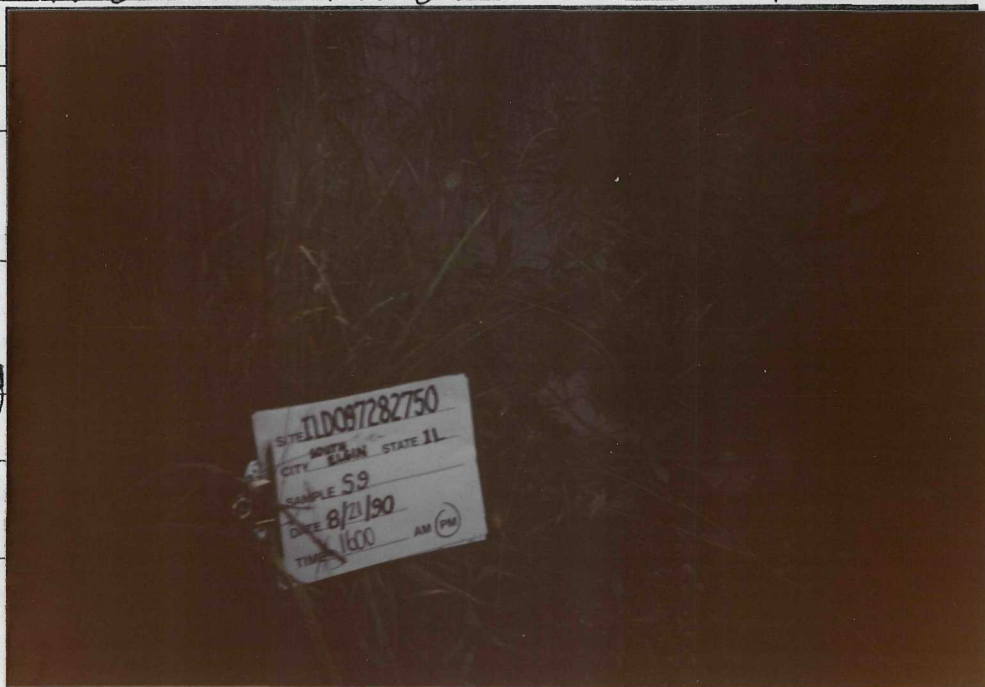
DESCRIPTION: Closeup of location at which sediment sample S9
was collected.DATE: 8/21/90TIME: 16:05DIRECTION OF
PHOTOGRAPH:NE

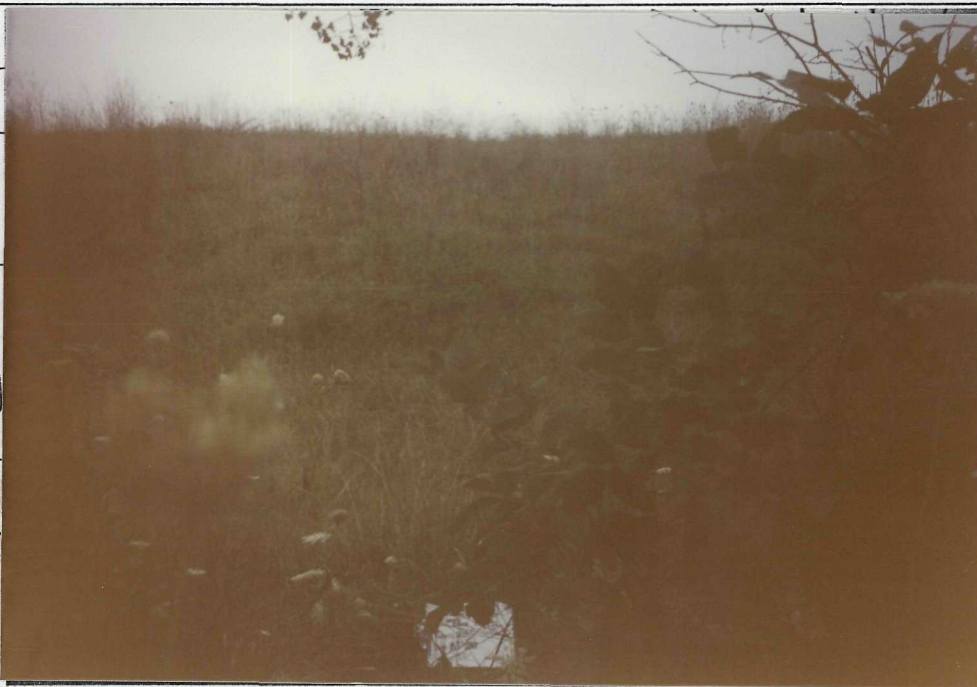
DESCRIPTION: Perspective view of sediment sample S9 collected
FROM THE SOUTHERN side of the site.

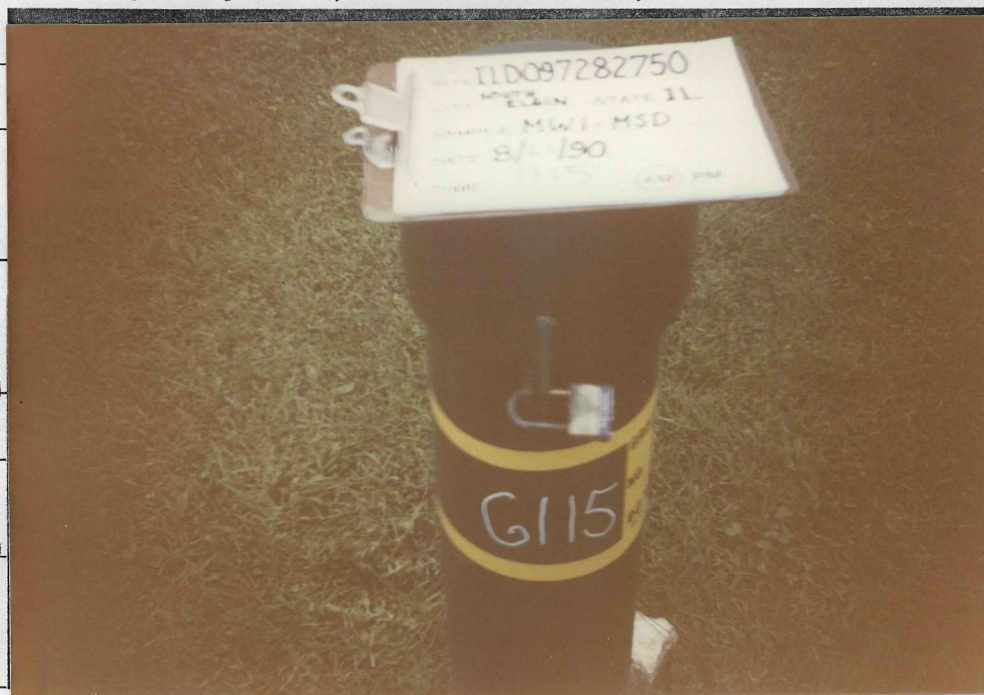
SITE NAME: Woodland LandfillPAGE 10 OF 15U.S. EPA ID: ILD097282750 TDD: F05-8909-044PAN: FIL0193SADATE: 8/21/90TIME: 1610DIRECTION OF
PHOTOGRAPH:
NNWWEATHER
CONDITIONS:
cloudy, drizzling
70°FPHOTOGRAPHED BY:
Daniel SullivanSAMPLE ID
(if applicable):
MW1-MSDDESCRIPTION: Closeup of Monitoring well MW1.

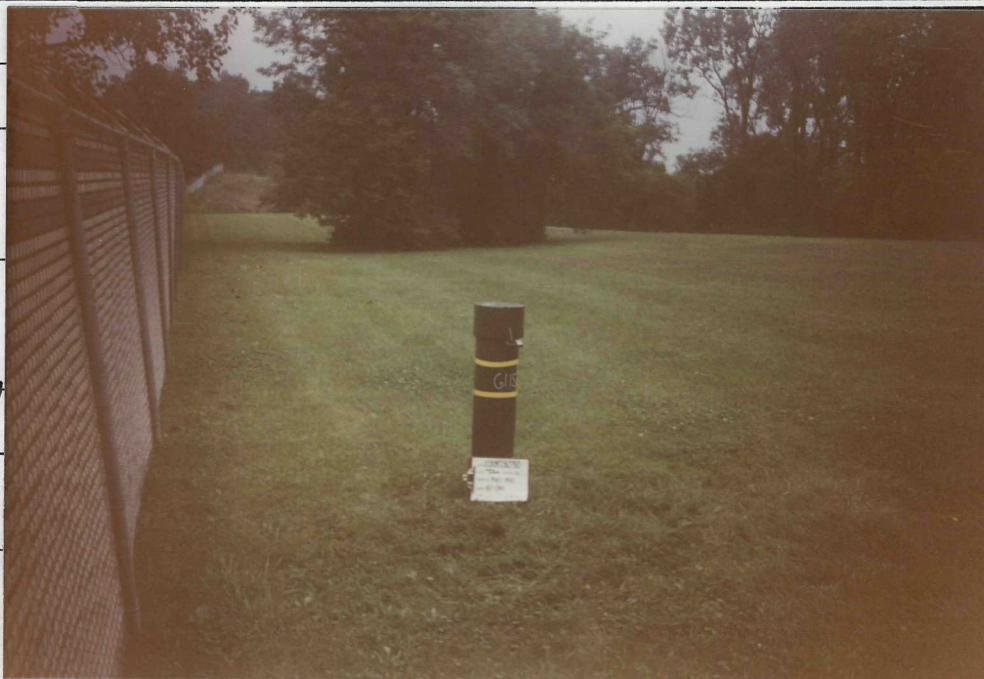
DATE: 8/21/90TIME: 1610DIRECTION OF
PHOTOGRAPH:
NNEWEATHER
CONDITIONS:
cloudy, drizzling,
70°FPHOTOGRAPHED BY:
Daniel SullivanSAMPLE ID
(if applicable):
MW1-MSDDESCRIPTION: Perspective view of MW1 located at the
southwest portion of the site.

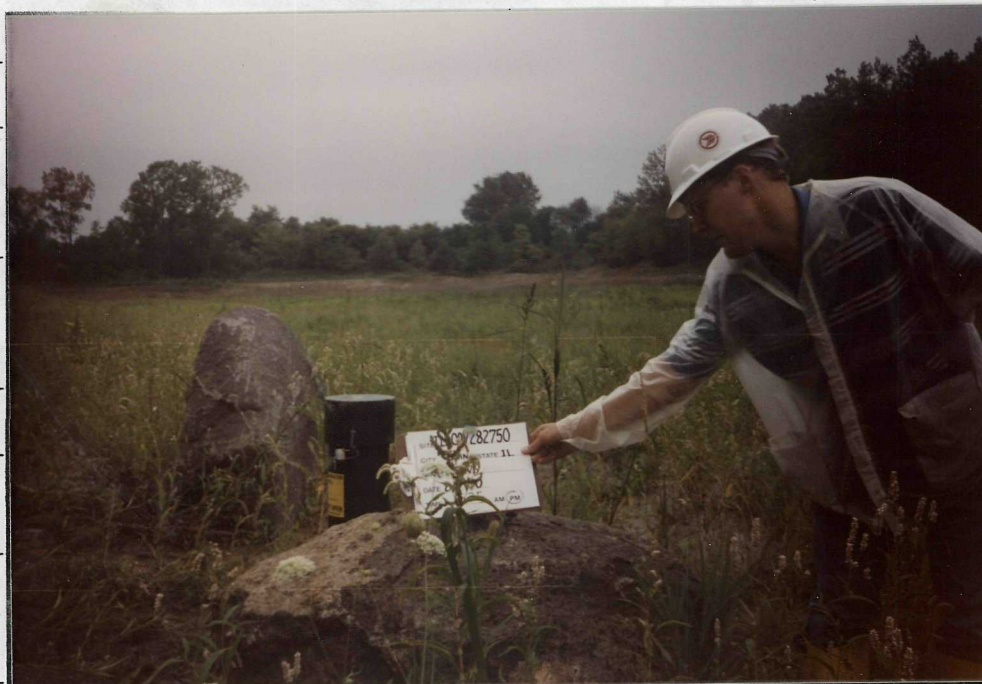
DESCRIPTION: Close up view of MW-6

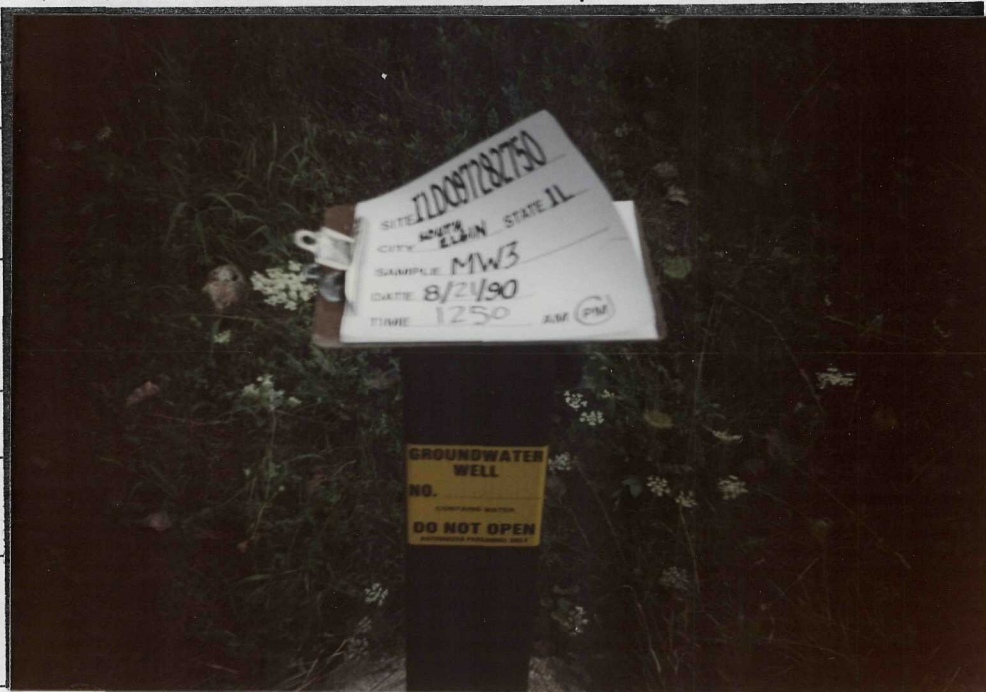
DESCRIPTION: Closeup of Monitoring well MW3.DATE: 8/21/90TIME: 1628DIRECTION OF
PHOTOGRAPH:
E

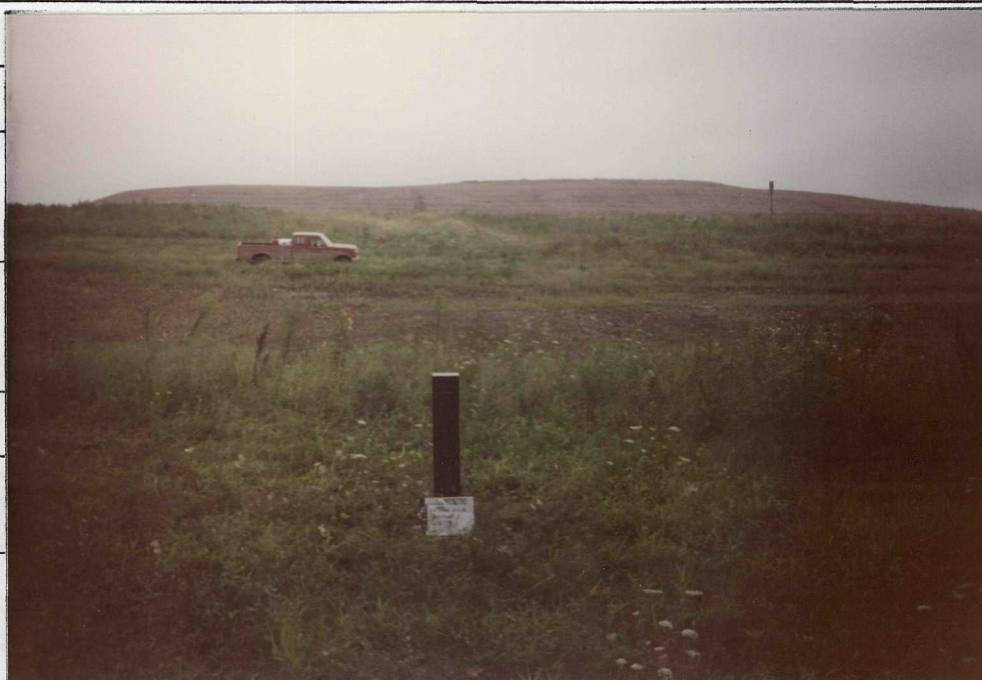
DESCRIPTION: Perspective view of Monitoring well MW3 located
in the central western portion of the site.

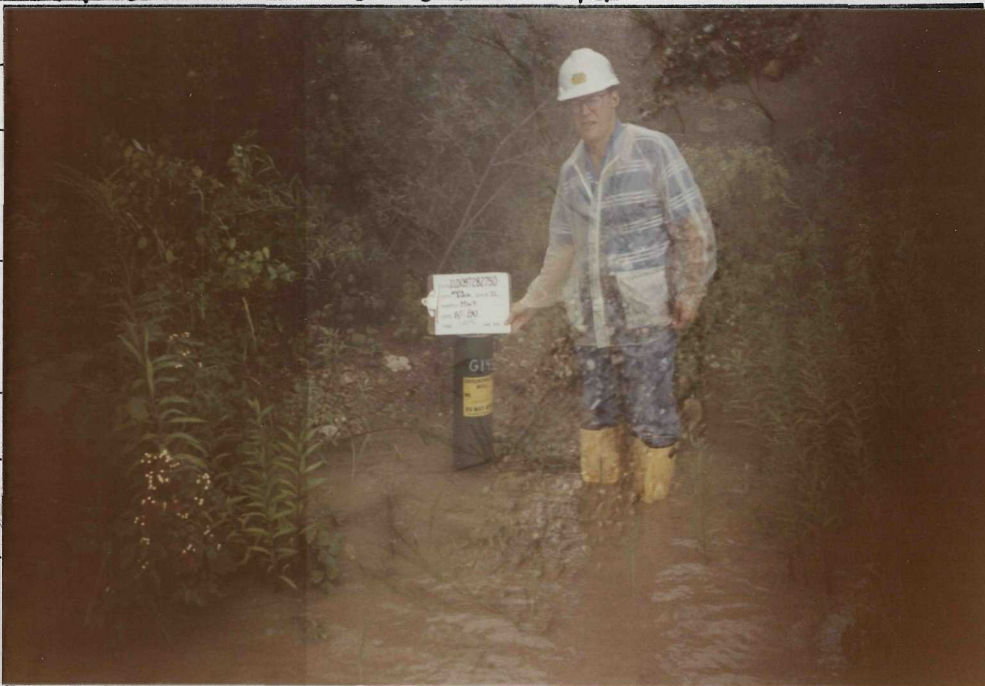
DESCRIPTION: Perspective view of Monitoring well MW4.DATE: 8/21/90TIME: 1420DIRECTION OF
PHOTOGRAPH:N

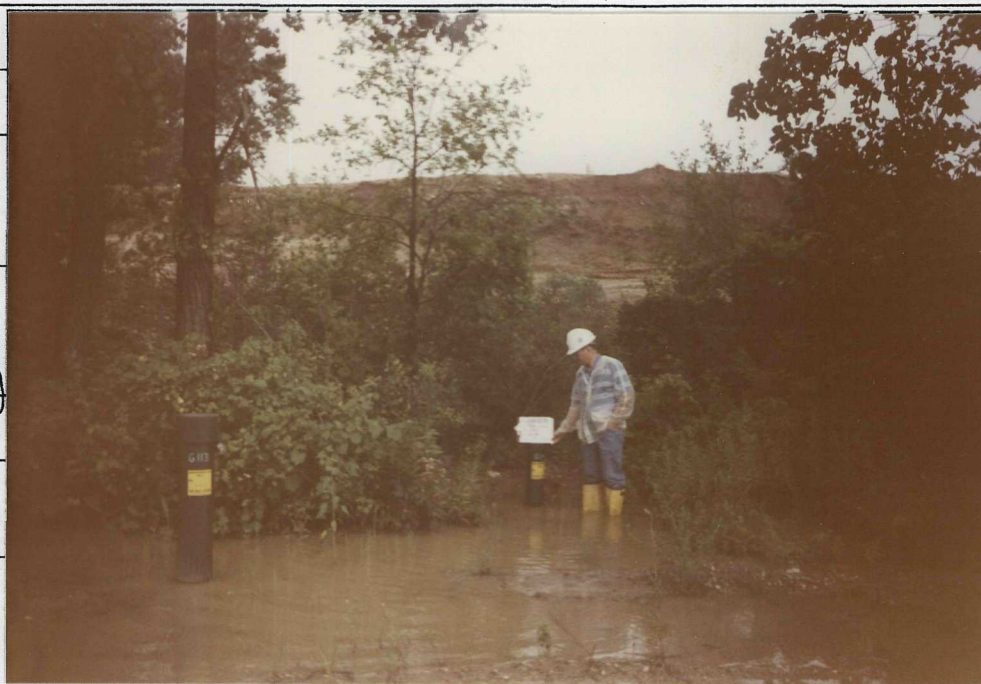
DESCRIPTION: Perspective view of Monitoring well MW4 located
in the southern central portion of the site.

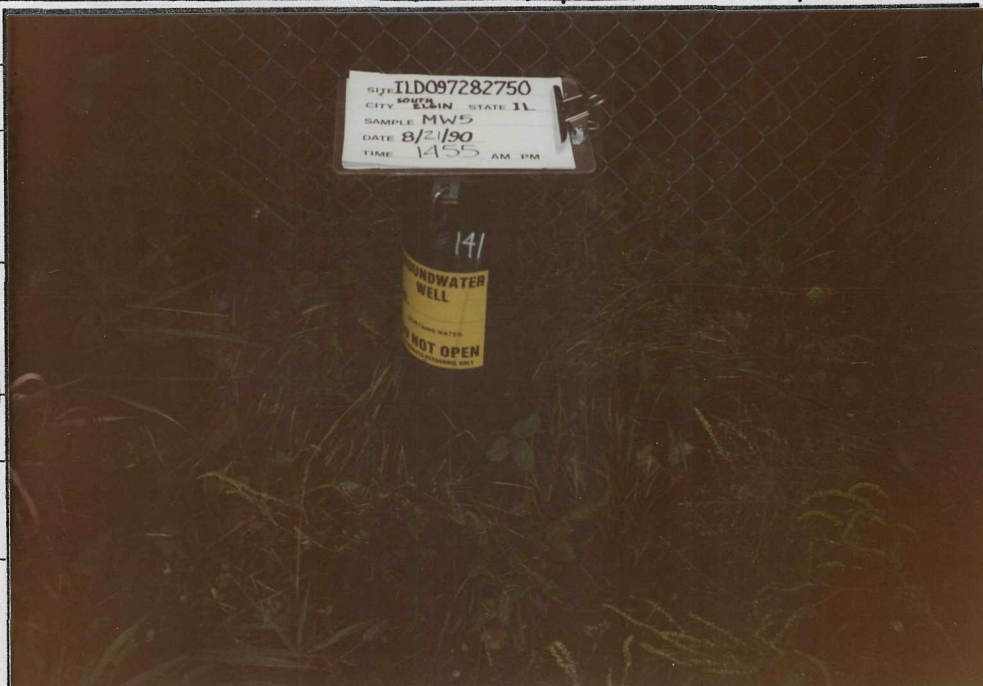
Closeup of Monitoring well MW5, the potential
upgradient sample located in the eastern central portion of the site.DATE: 8/21/90TIME: 15:45DIRECTION OF
PHOTOGRAPH:W

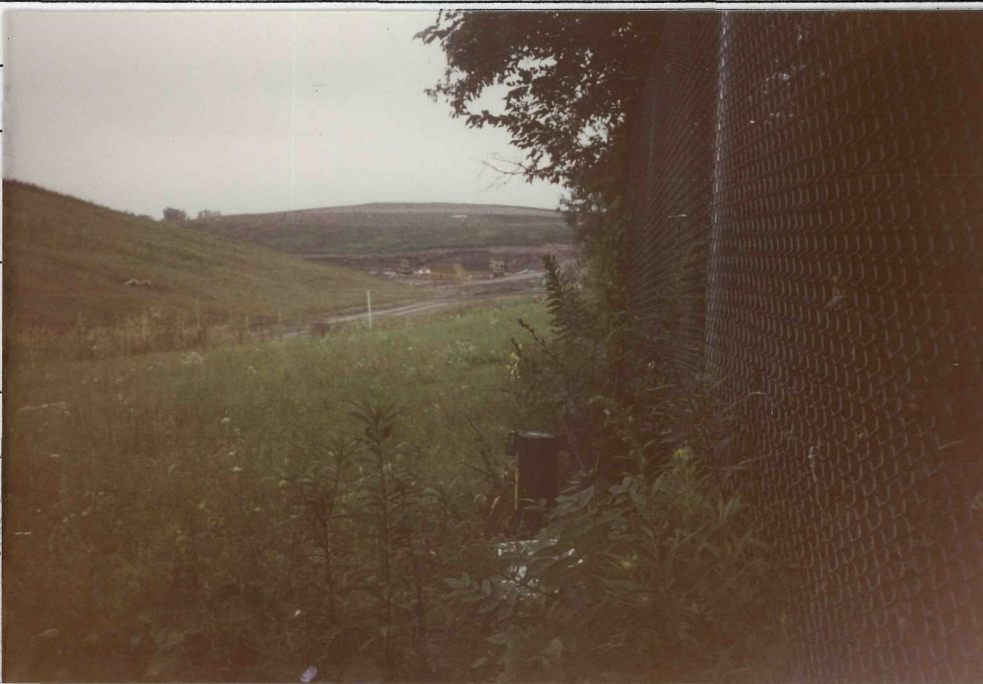
Perspective view of Monitoring well MW5 located
at the eastern central area of the site.
